Memo

TO: Dr. Chase and Mary O'Neill
FROM: Karen Chubak, CSArch
DATE: August 27, 2019
PROJECT: GCSD Mansion Exterior Assessment
CSArch Project No. 166-1906
PAGES: 4

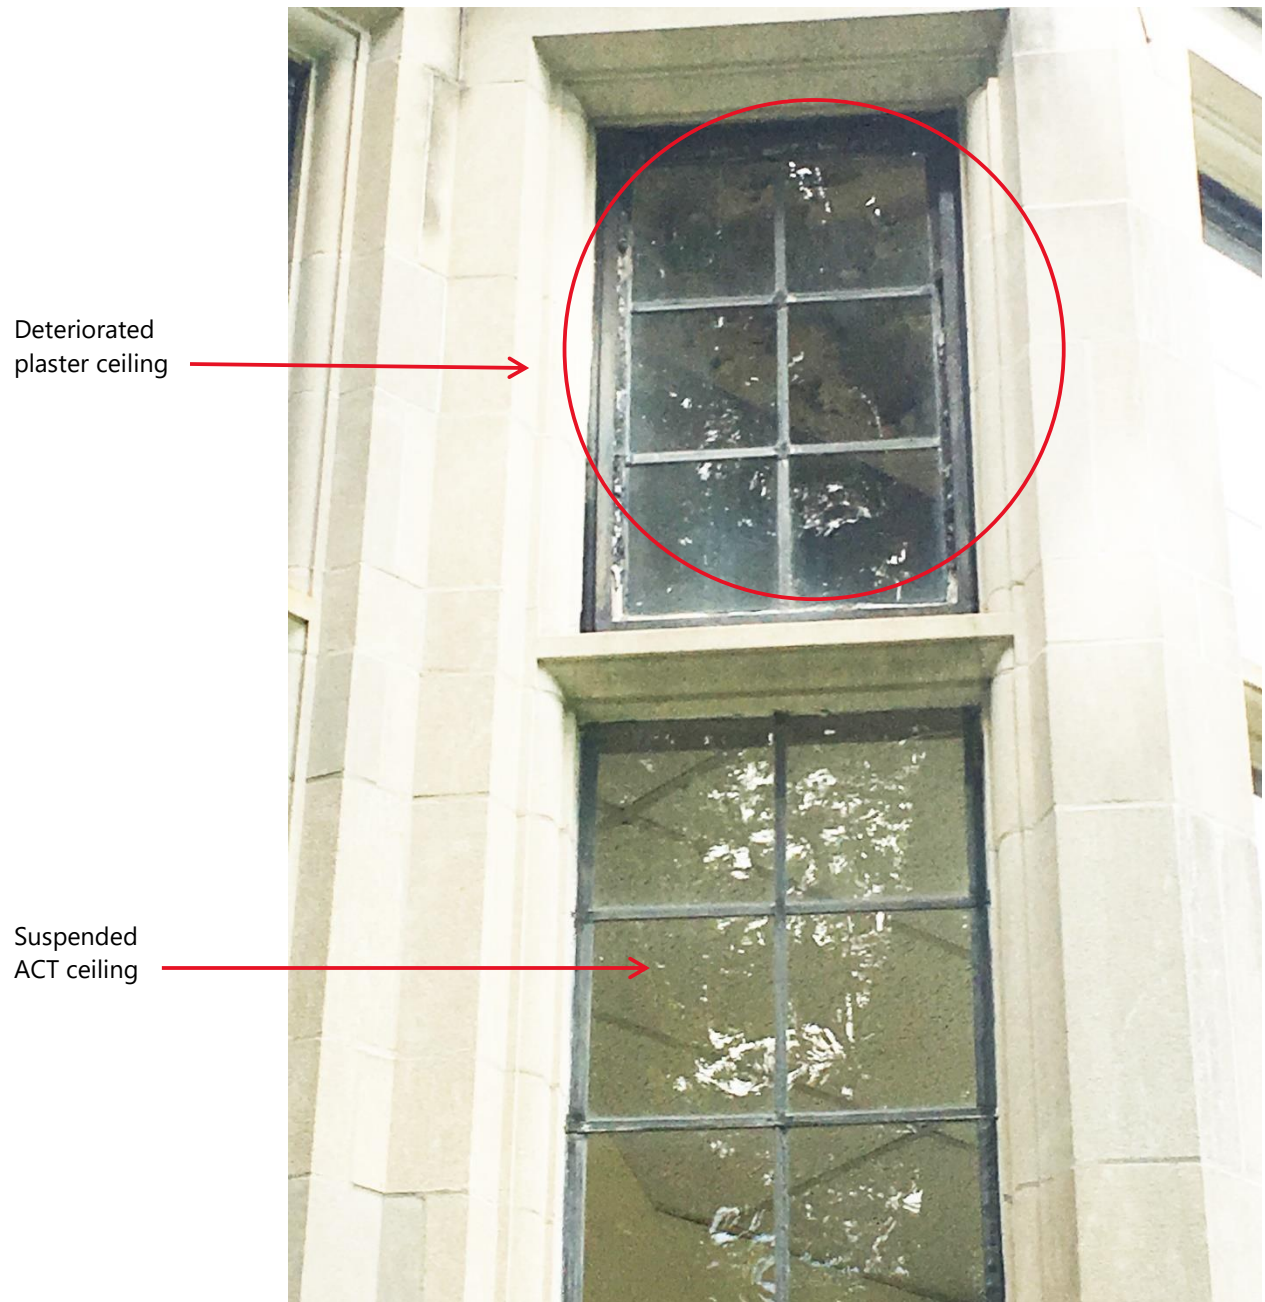
Photo of Item #1

The south portion of the building currently contains two ECP classrooms. These spaces have an acoustical tile ceiling (ACT) which is suspended below the original dropped plaster ceiling. It is unclear whether this ACT ceiling is attached to the plaster ceiling or to the roof structure above it. The roof above this space is deteriorated and has been the cause of water infiltration in the adjacent wing where Dr. Chase's office is located. The ACT shows signs of water damage (brown tiles) and the plaster ceiling above it appears deteriorated – the plaster ceiling can only be seen in part from the backyard through the high windows in this space.

In two offices on the North side of the building, original plaster ceilings have collapsed suddenly in areas where they were located below a leaking roof.

CSArch and DiSalvo are seriously concerned with the structural integrity of the plaster ceiling located above the dropped ACT ceiling over the two ECP classrooms. This plaster ceiling is likely deteriorated due to water infiltration. CSArch and DiSalvo recommend that portions of the ACT ceiling be removed so that the concealed plaster ceiling can be properly evaluated and removed if necessary. Failure to do so might put GCSD at risk if the plaster ceiling collapses suddenly as it will likely cause the ACT ceiling to collapse as well.

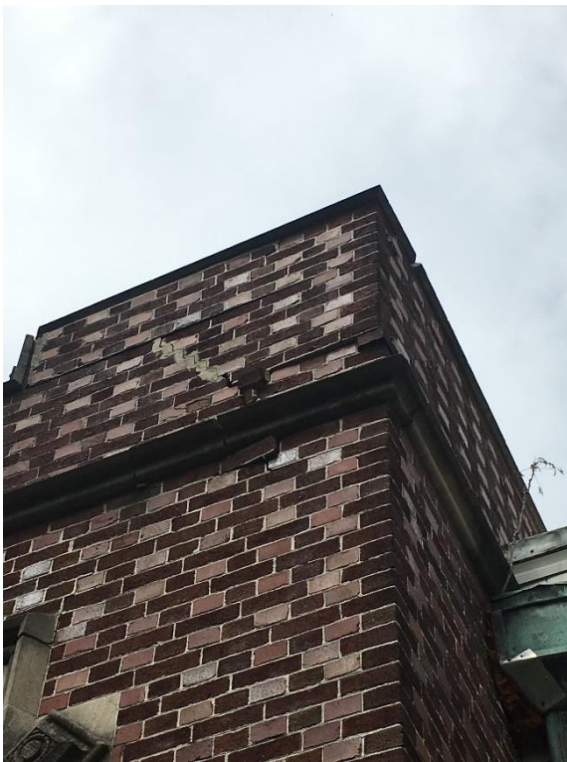
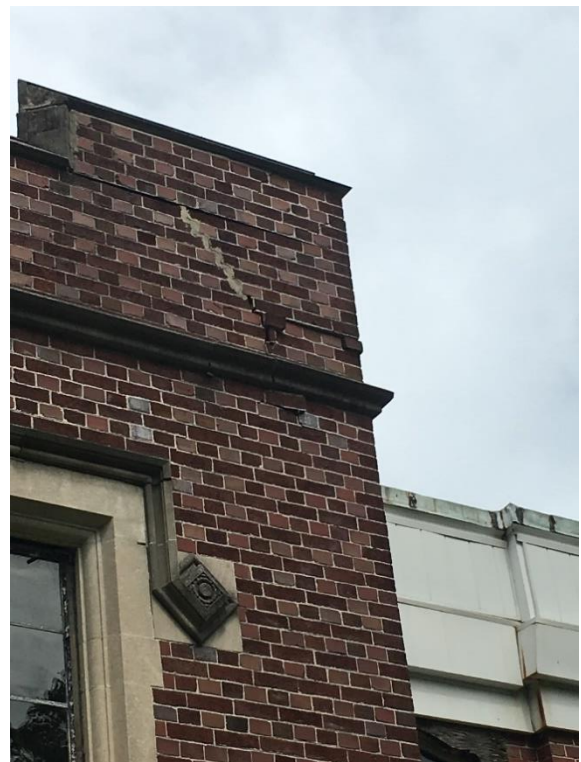
Photos of Item #2

The south portion of the building is clad in brick. The parapet portion of this brick façade exhibits serious cracks at the outside corners. The movement of this masonry has caused bricks to be partially dislodged and the stone coping above them has been partially lifted and has shifted.

CSArch and DiSalvo are seriously concerned with the structural integrity of these areas on the brick parapet and the possibility of bricks and/or stone falling off the building. This parapet overlooks the ECP playground. CSArch and DiSalvo recommend that loose portions of masonry parapet be carefully removed, and the remainder of the parapet be stabilized and protected from the elements with necessary tarps and netting. These areas of the parapet will need to be repaired by a skilled mason as these parapets are an important feature of this ornate portion of the façade.

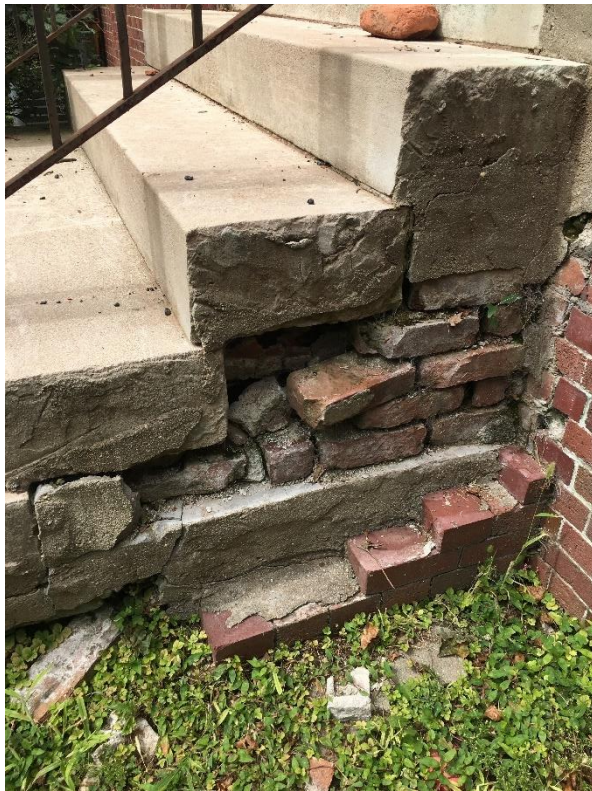
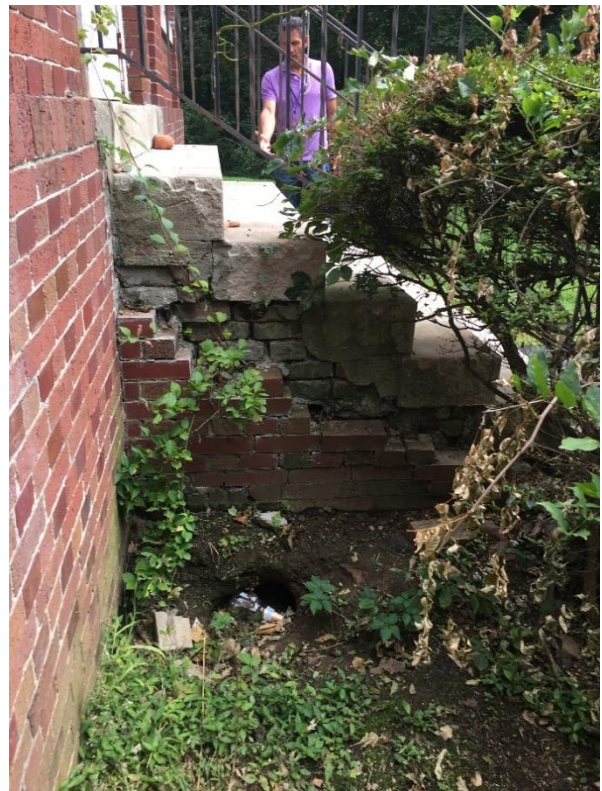
Photos of Item #3

The southeast portion of the building has steps leading to grade that are seriously deteriorated. Bricks cladding underneath the steps and below the stone steps themselves have started to dislodge.

CSArch and DiSalvo are concerned with the structural integrity of these steps. These steps are used daily by ECP students and teachers for playground access. CSArch and DiSalvo recommend that these steps be taken out of use and repaired by a skilled brick mason.

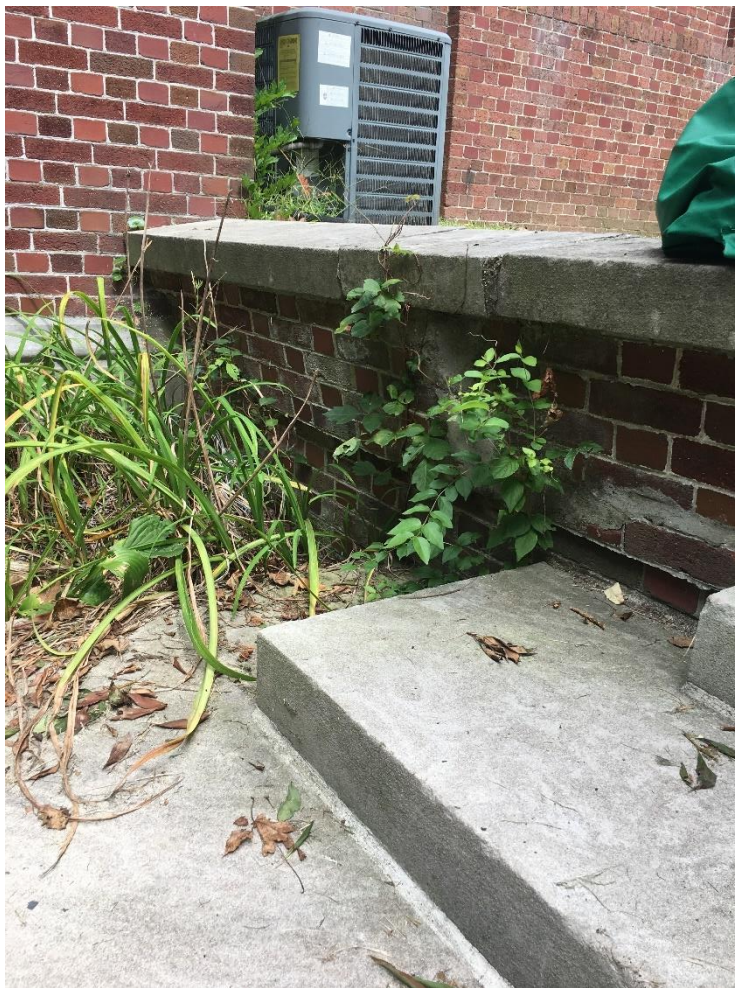
Photo of Item #4

The retaining wall directly adjacent to the steps mentioned in item #3 is slowly collapsing as the upper five courses of brick are visibly out of plane with the lower portion of the wall.

CSArch and DiSalvo are concerned with the structural integrity of this retaining wall. This wall is adjacent to stone steps used daily by ECP students and teachers for playground access. CSArch and DiSalvo recommend that these steps be taken out of use and the wall be repaired by a skilled brick mason.
