Greenburgh Mansion
Structural Assessment Report

**Greenburgh ECP Building
and RJ Bailey**
Structural Overview Report

September 16, 2019

TO: Dr. Tahira DuPree Chase
FROM: Tina Mesiti-Ceas, CSArch
DATE: September 16, 2019
PROJECT: GCSD Summary of Structural Assessments for the Mansion, ECP and RJ Bailey
CSArch Project No. 166-1906

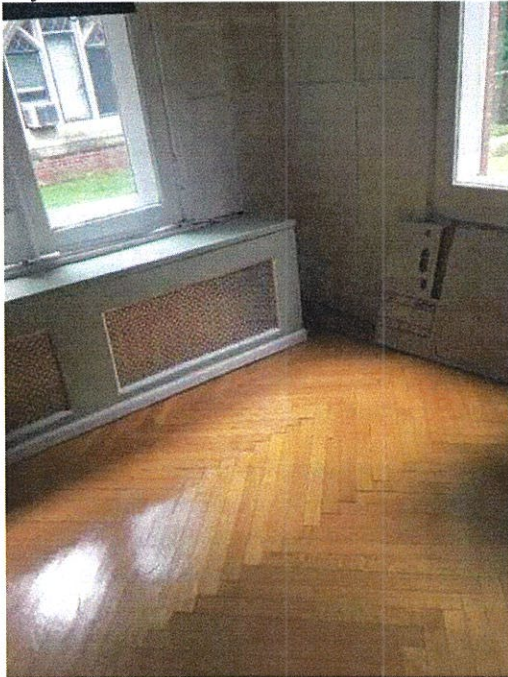
Photo 1

- Though projecting wood floor framing members are visibly and severely deteriorated on the outside of the building, one of the probes showed that the floor structure is generally in good condition.
- Based on a visual inspection of a probe, the cause of changes in the floor levels at two locations on the ground floor, appear to be a result of partially failed foundation level structural members due to damage from water infiltration [photos 1-2.]
- A 2nd floor area of differential floor level was found to be due to a failure of the original floor framing details, none of which was visible until probing. This enclosed cantilevered space is visibly sagging on the outside as well [photo 3.]
- A probe in the ceiling of the garage around an area of damaged plaster revealed deterioration of the porch floor structure above due to a roof leak. [photos 4-6.]

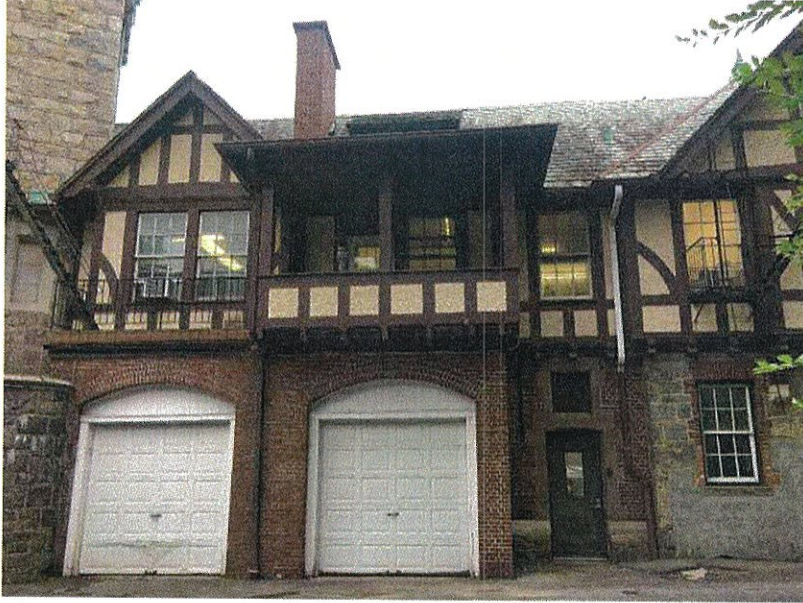
Photo 4 – overall view of roofed porch

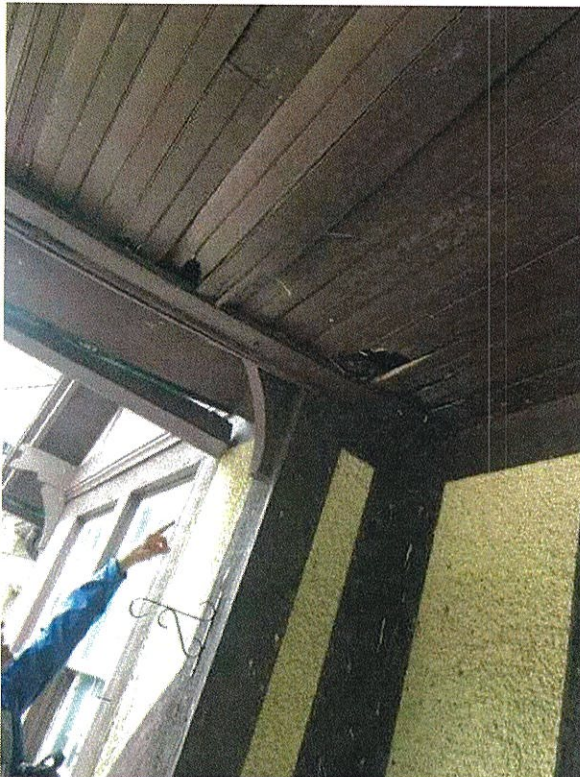
Photo 5 – Deteriorated porch roof

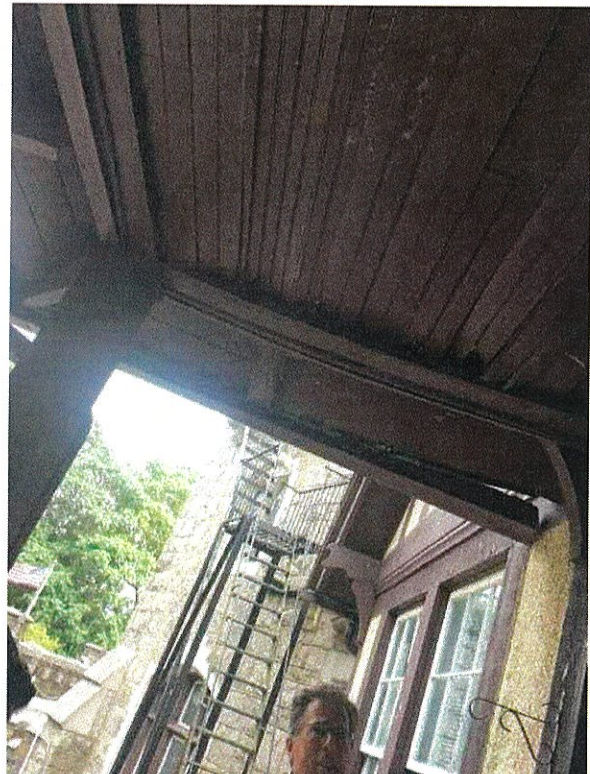
Photo 6 – Deteriorated porch roof

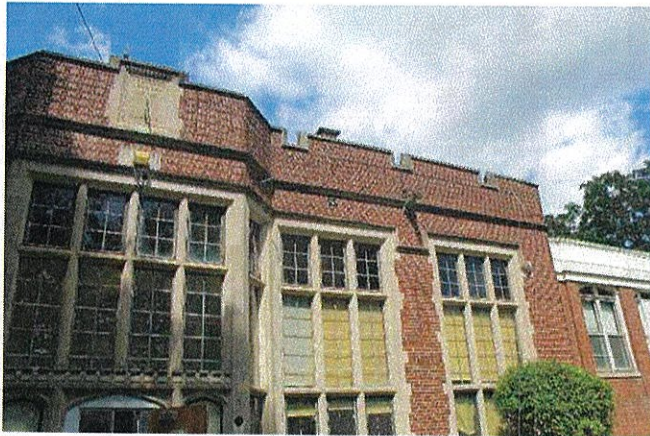
- E1. Portions of the brick parapet along the edge of the flat roof at the south end of the building, above the Pre-K classrooms, are cracked and displaced outward.
- E2. The low brick site retaining wall outside the classroom area is shifted and out of plumb.
- E3. The site retaining wall near the west side of the building has collapsed and the resulting exposed sloping grade is eroding towards the building.
- E4. Portions of the exposed timber elements at the first floor on the west elevation are deteriorated. (The timber elements were viewed from an interior probe at this location and no significant deterioration of the first-floor framing was noted.)

E1. Brick Façade and Parapet at Pre-K Classrooms

- R1. Repair/replace the cracked and displaced portions of the brick parapet along the edge of the flat roof at the south end of the building, above the Pre-K classrooms.

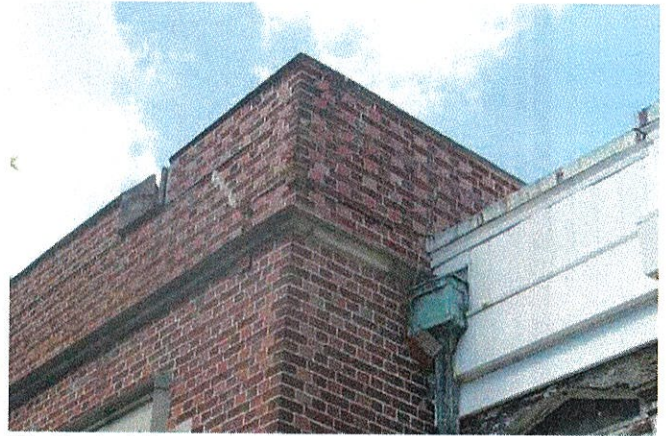
E1. Cracked Parapet

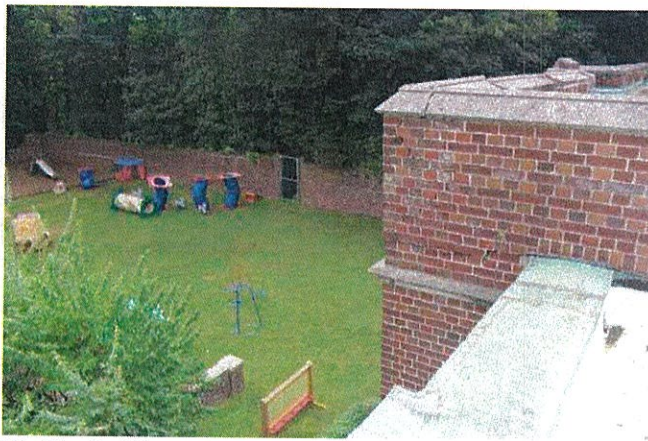
E1. Cracked Parapet

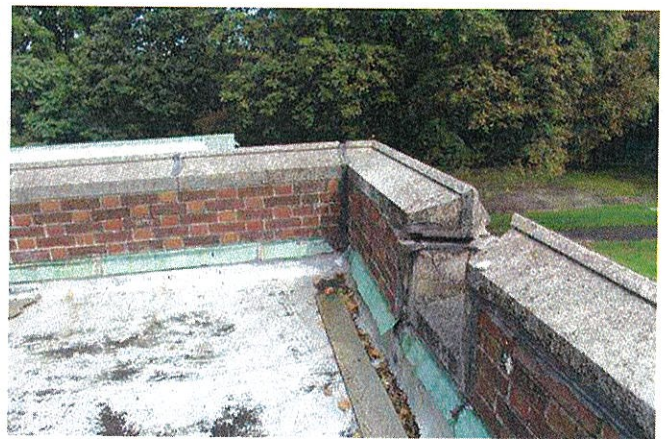
E1. Cracked Parapet

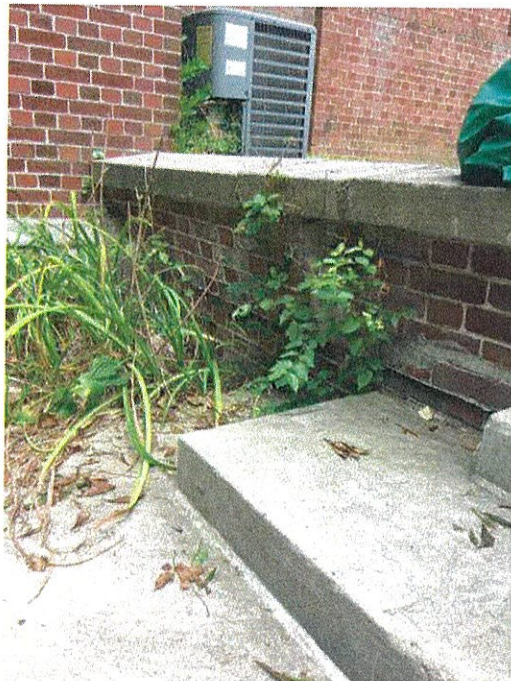
E2. Displaced Site Wall (photo by CSArch)

- R2. Repair the shifted low brick site retaining wall outside the classroom area.
- R3. Replace the site retaining wall near the west side of the building. Temporary support of retained soil between the building foundation and new wall may be required to prevent undermining the building foundation.

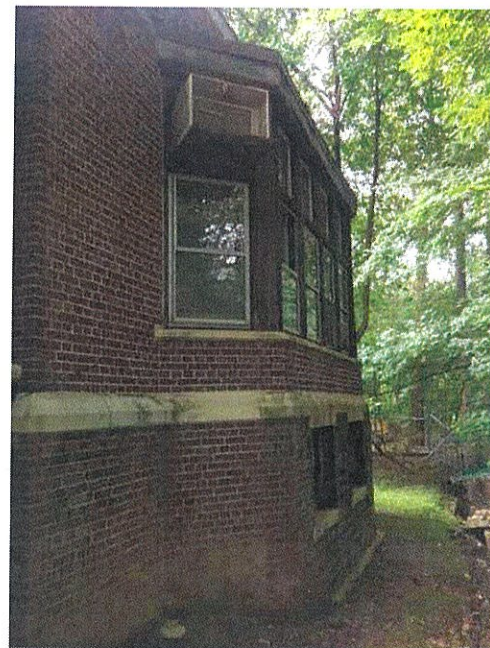
E3. Failed Site Retaining Wall at Far Right – note proximity to the building foundation (photo by CSArch)

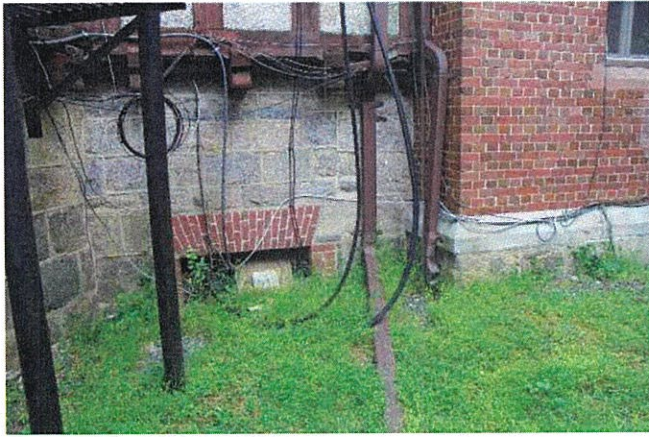
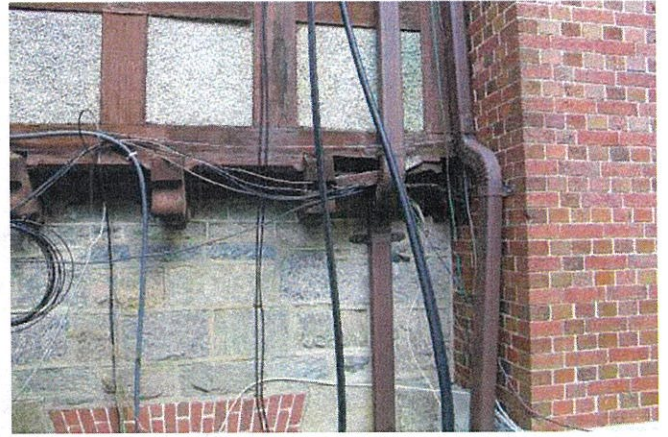
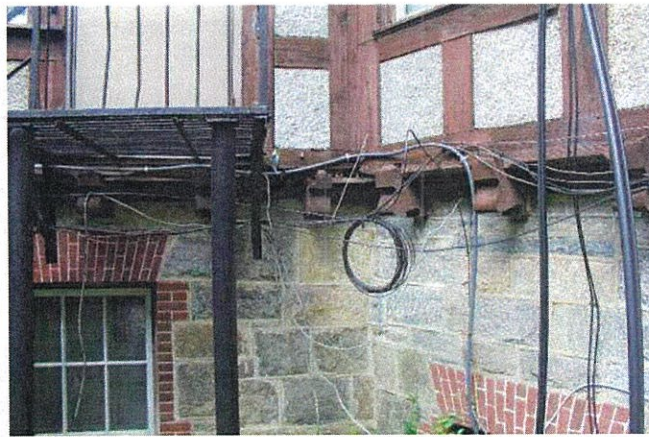
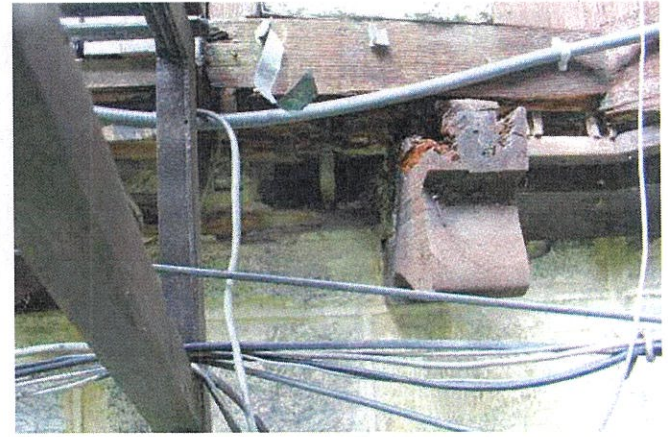
E4. Deteriorated Exposed Timber Elements

- R4. Repair the deteriorated portions of the exposed timber elements at the first floor on the west elevation.
- R5. Repair the cracked and displaced portions of the exterior brick work and foundation at the first floor on the west elevation, below the open-air porch. See Repair Item R12 and Additional Investigation Note 1 below.

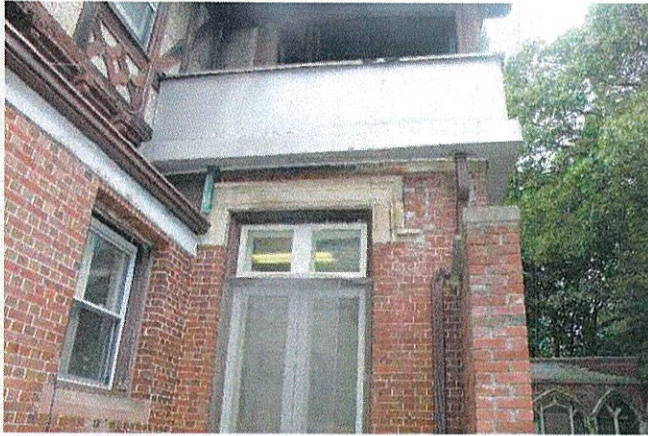
- E5. Portions of the exterior brick and stone work at the first floor on the west elevation, below the open-air porch, are cracked and displaced. (Note: The floor on the interior side of this portion of the wall is displaced. See note I2 below.)

E5. Cracked and Displaced Brick Masonry

- 1. Excavate the foundation walls at the areas of the cracked and displaced portions of the exterior brick work at the first floor on the west elevation below the open-air porch to determine the integrity of the foundations and the extent of the repair required.
- 2. Remove the soffit of the cantilevered portion of the second floor at the west elevation and expose the existing support condition to determine the nature and extent of the repair required. This investigation should take place after temporary shoring is installed.

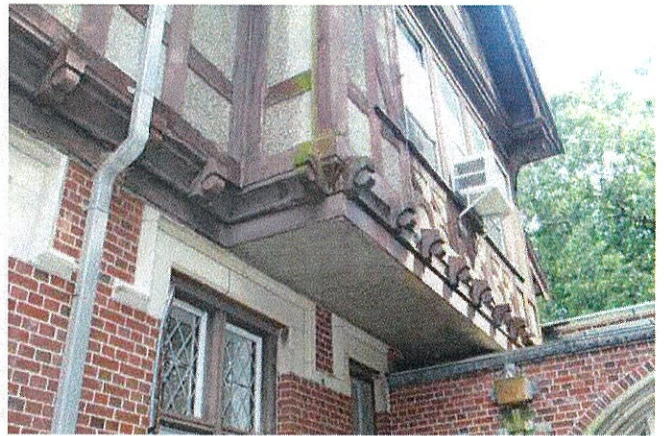
E6. Cantilevered Second Floor

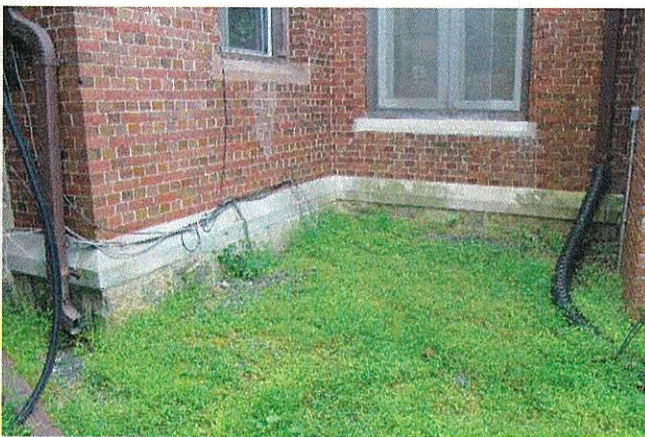
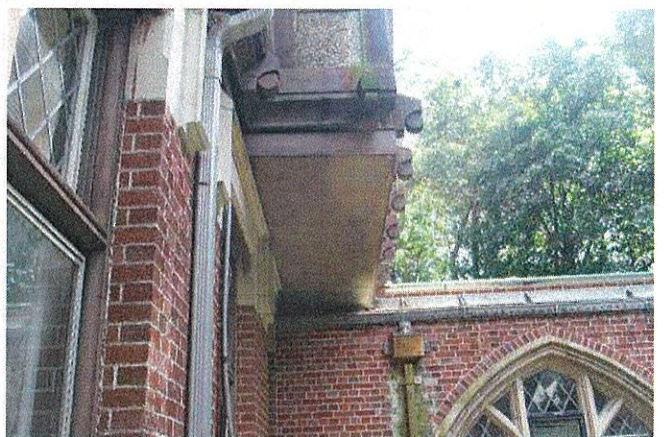
E6. Cantilevered Second Floor – note sagging soffit

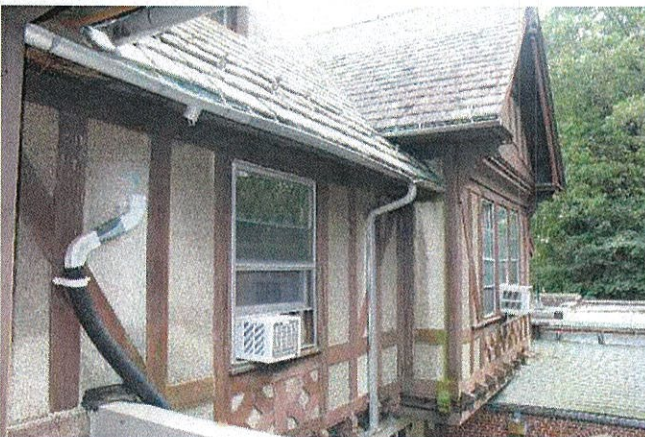
E6. Cantilevered Second Floor

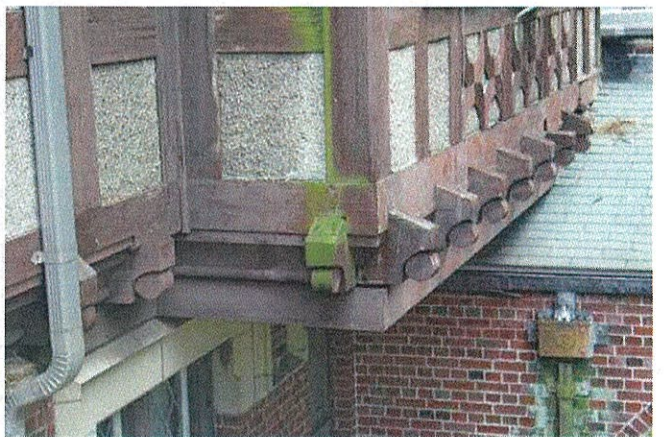
E6. Cantilevered Second Floor

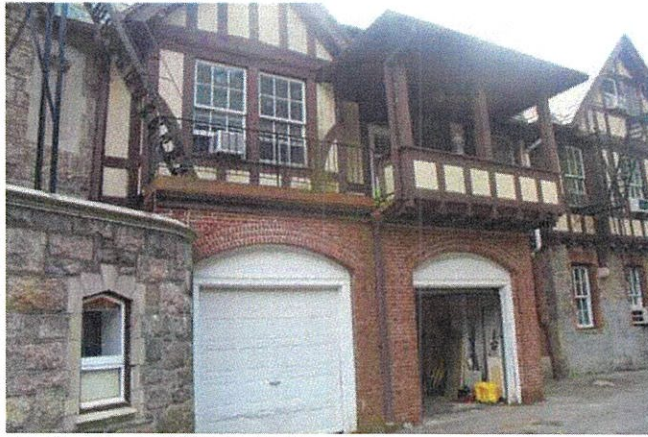
- E7. Portions of the exposed timber framing at the second-floor cantilevered open porch at the north elevation are deteriorated. (Deteriorated second floor framing is evident from below).

E7. Cantilevered Open-Air Porch

- R7. Repair the deteriorated portions of the exposed timber framing at the second-floor cantilevered open porch at the north elevation.
- R8. Repair/restore the exterior masonry as required. Coat the exposed masonry elements with a clear penetrating water repellent sealer.

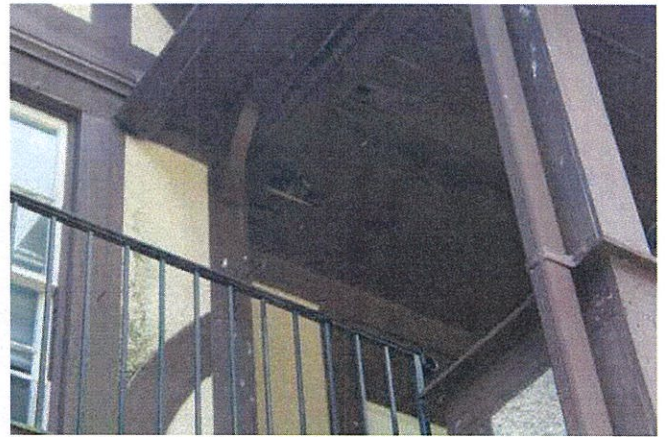
E7. Deteriorated ceiling and timber framing

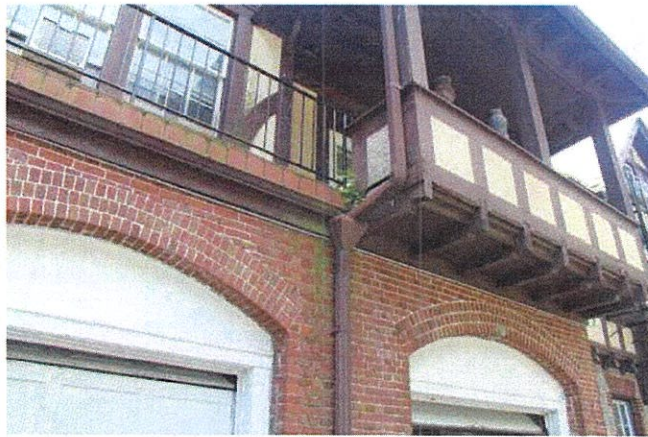
E7. Cantilevered Open-Air Porch

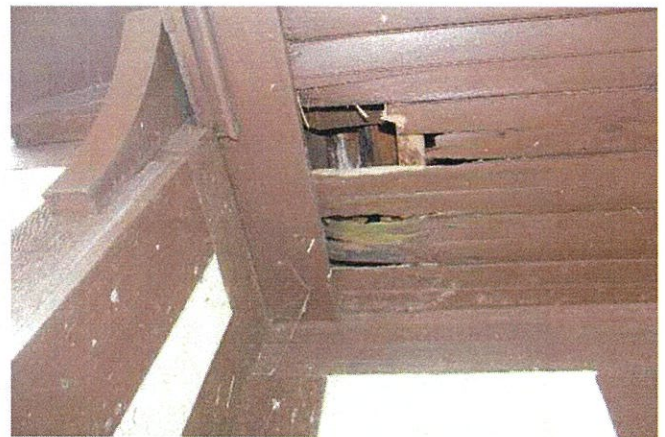
E7. Deteriorated ceiling and timber framing

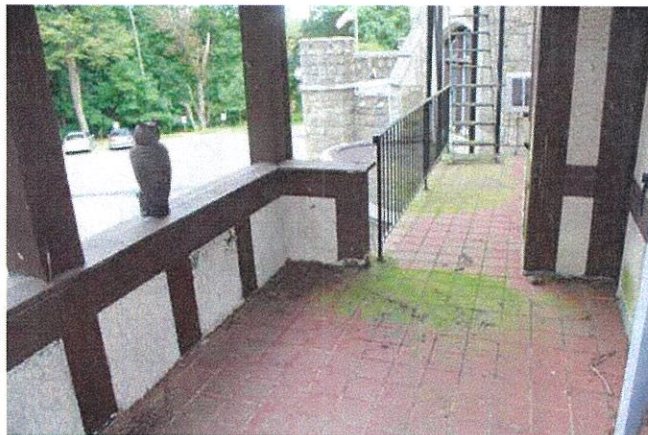
E7. Porch

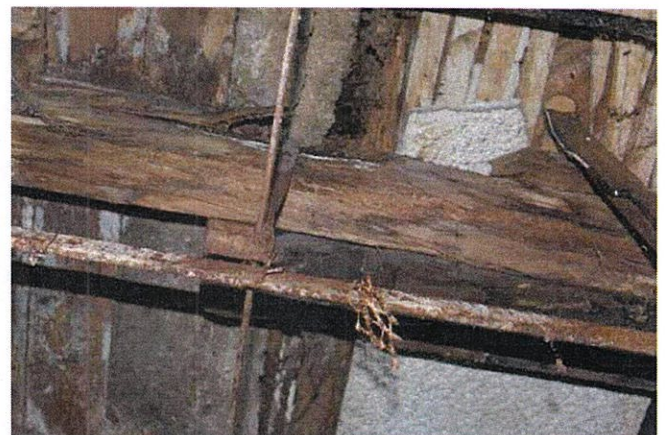
- I4. The second-floor framing at the cantilevered open porch at the north elevation is deteriorated due to moisture intrusion from above. See note E7 above.

E7. And I4. Deterioration of porch floor framing due to water infiltration

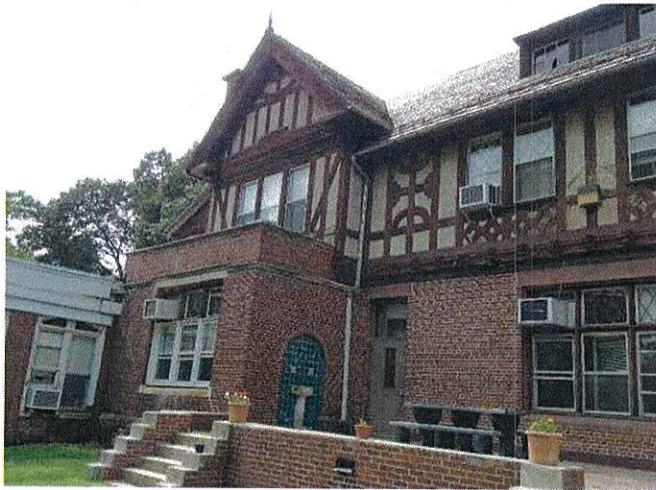
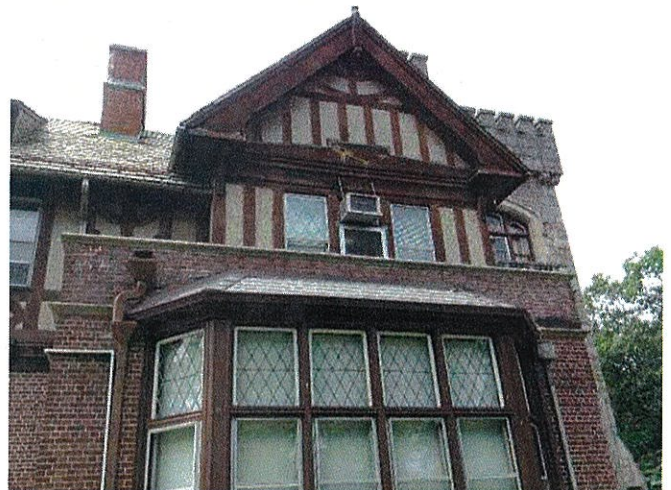
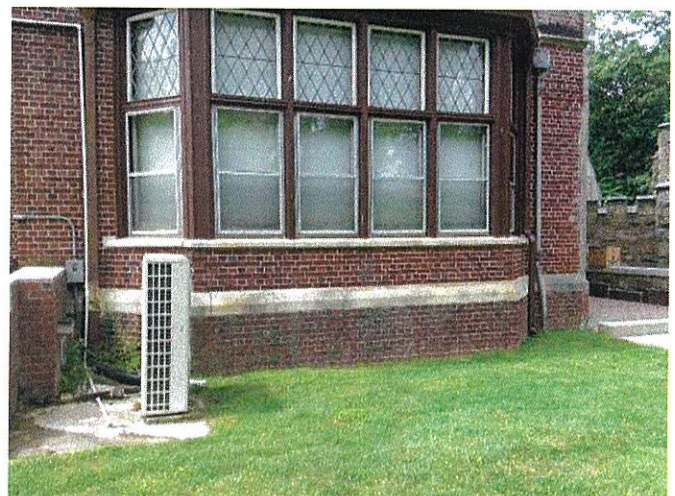
- E8. The remainder of the exterior masonry elements of mortared stone and brick are in generally fair condition. No significant areas of deterioration were noted. Missing mortar and some cracked bricks were noted throughout.

- E9. The remaining exposed exterior timber elements are in generally fair condition. The paint coating is generally deteriorated and missing from some of the timber fascia boards.

E8. And E9. Typical Exterior Conditions

- R9. Repair/restore the remaining exposed exterior timber elements as required and clean and re-coat all the exposed timbers.
- R10. Implement a preventative maintenance program to be performed at regular intervals.

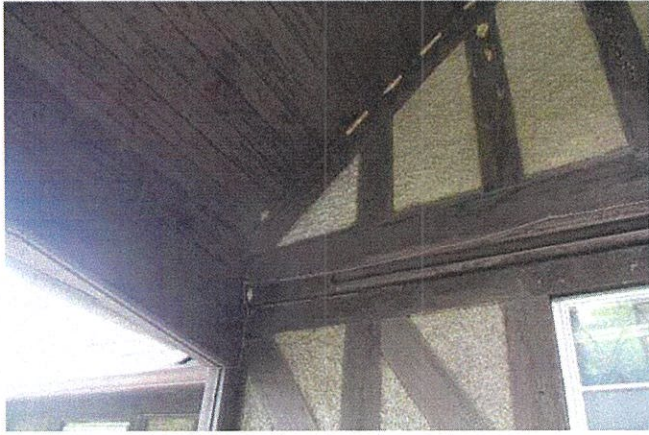
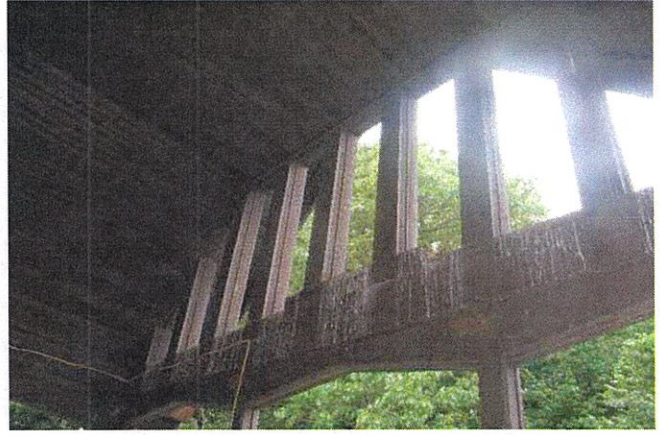
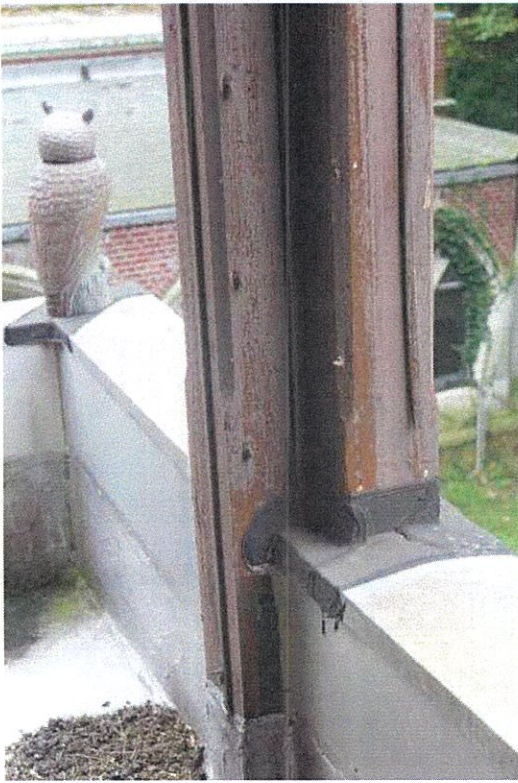
E9. Typical Exterior Conditions

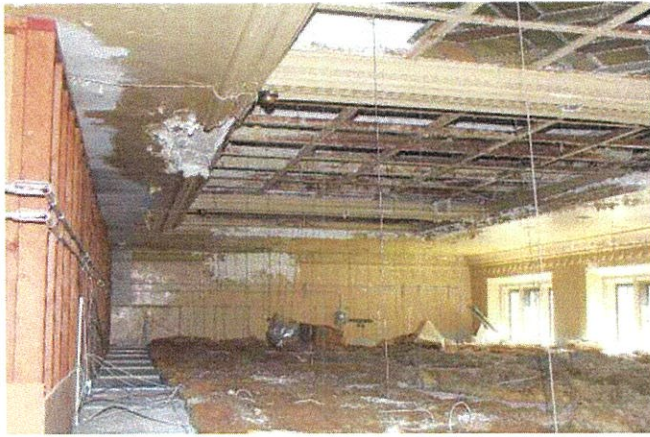
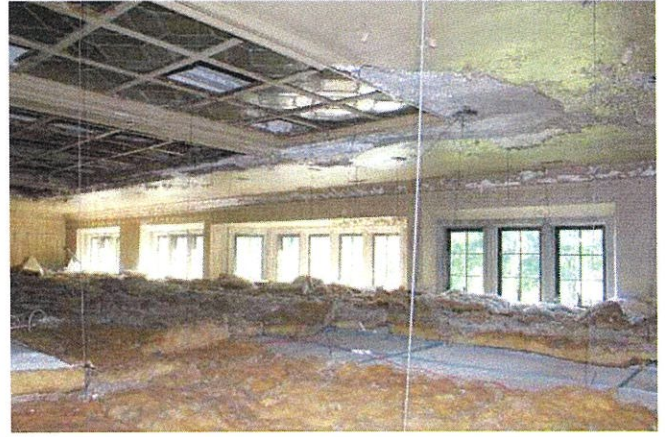
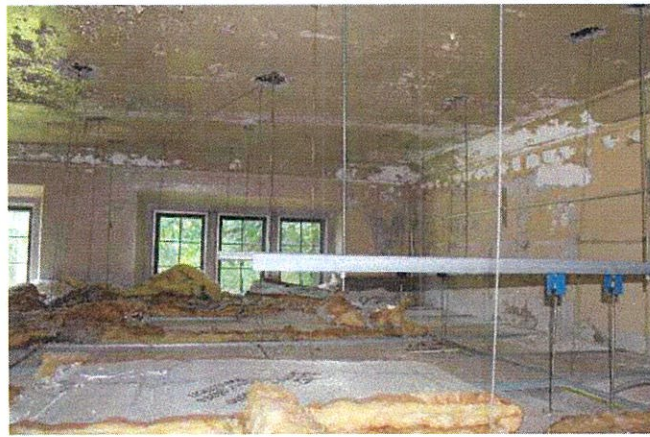
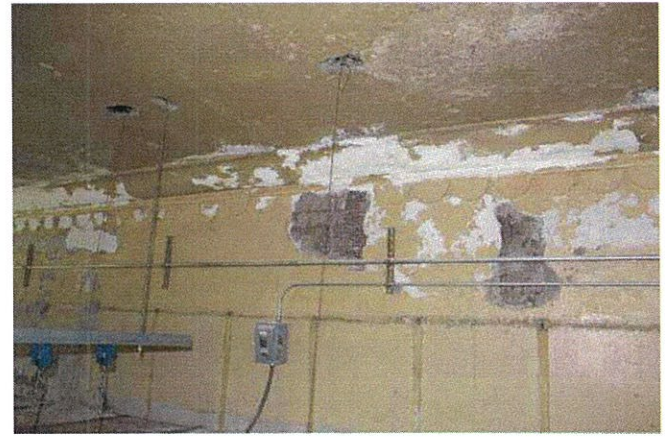
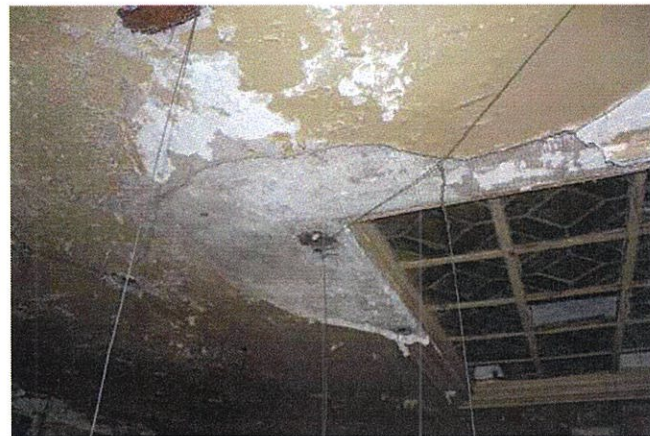
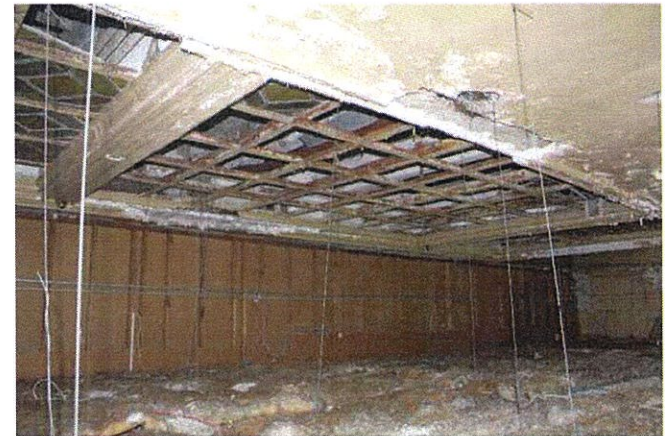
- I1. Portions of the original plaster ceiling at the Pre-K classrooms (above the hung ceiling) show evidence of previous moisture intrusion and are deteriorated or missing.

II. Plaster Ceiling Above Pre-K Classrooms

- R11. Remove the original plaster ceiling at the Pre-K classrooms (above the hung ceiling). The long-term exposure to moisture from the previous leaks around the skylight and from the previous indoor pool have affected the integrity of the plaster ceiling.
- R12. Repair the displaced first floor framing in the two corners of the office area below the second-floor open porch.
- R13. Re-support the second-floor framing at the displaced cantilevered portion.
- R14. Replace the second-floor framing at the cantilevered open porch at the north elevation.
- R15. Remove and replace the damaged plaster ceiling in the vicinity of the active roof leak above the second-floor office.

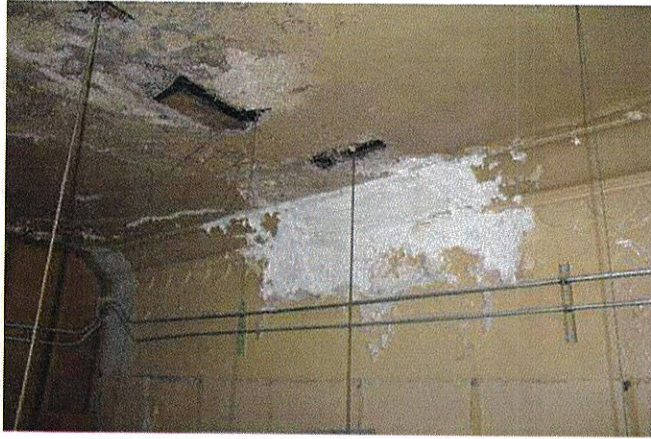
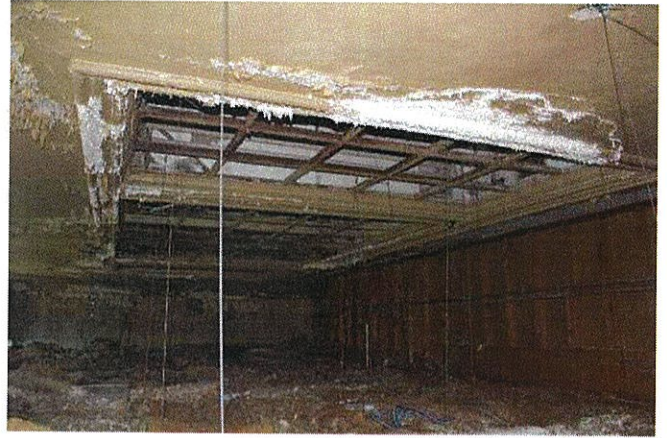
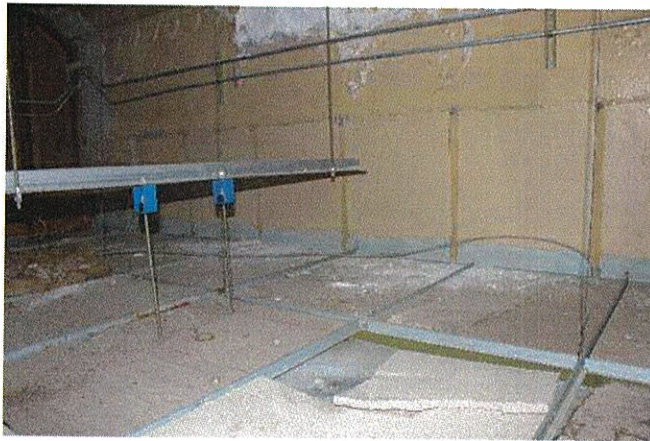
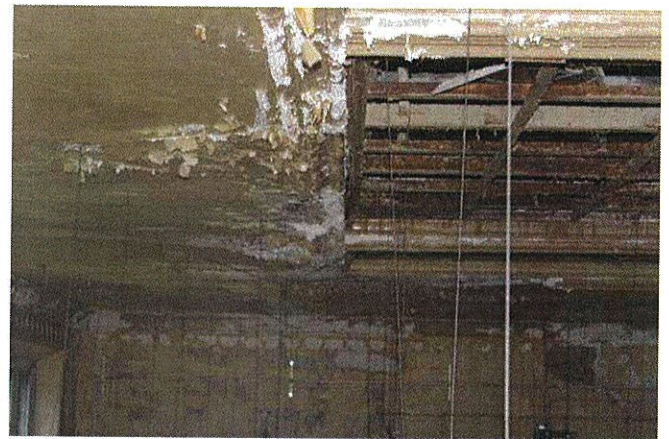
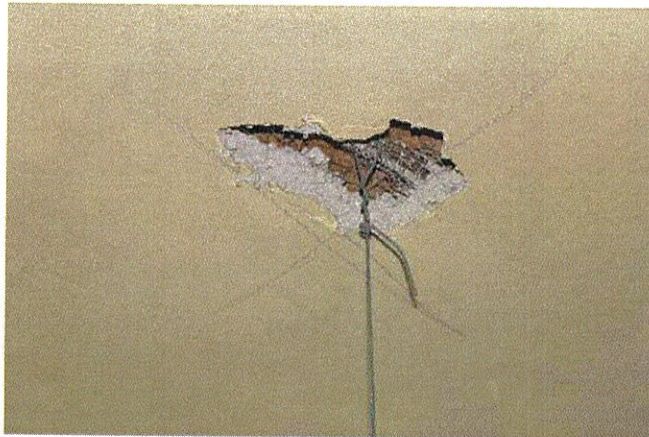
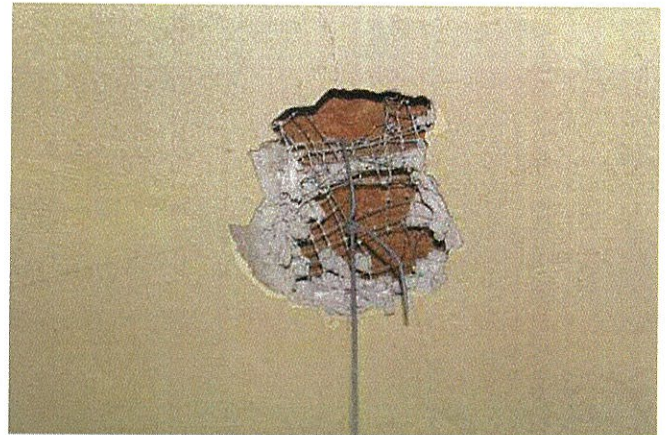
II. Plaster Ceiling Above Pre-K Classrooms

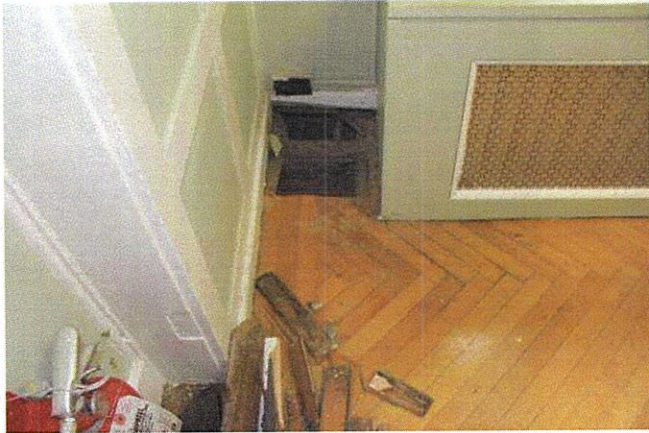
- I2. The first floor is significantly displaced in two corners of the office area below the second-floor open porch and in the vicinity of the cracked masonry in note E5 above. A probe through the floor finish revealed evidence of previous water intrusion and deterioration of the floor framing.

I2. Probe at First Floor

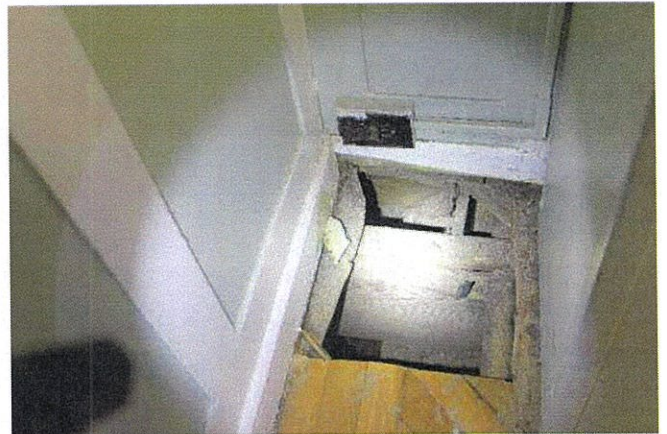
I2. Probe at First Floor

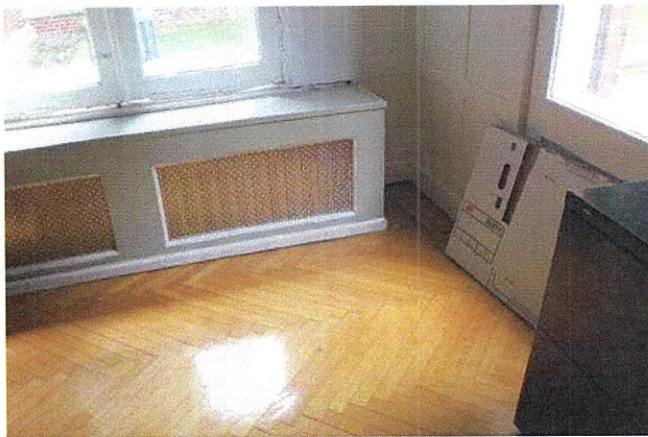
I2. Sloping First Floor

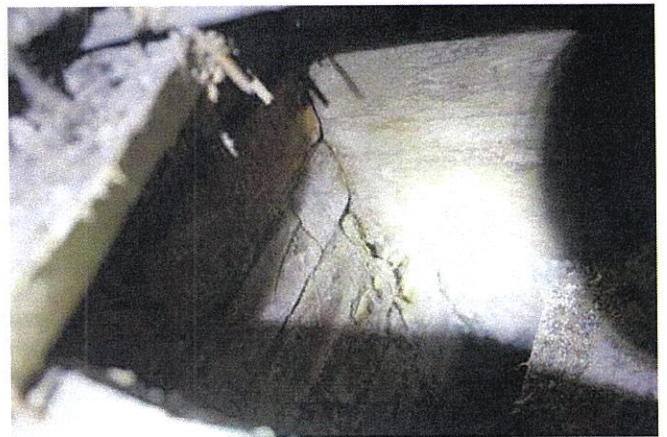
I2. Probe at First Floor

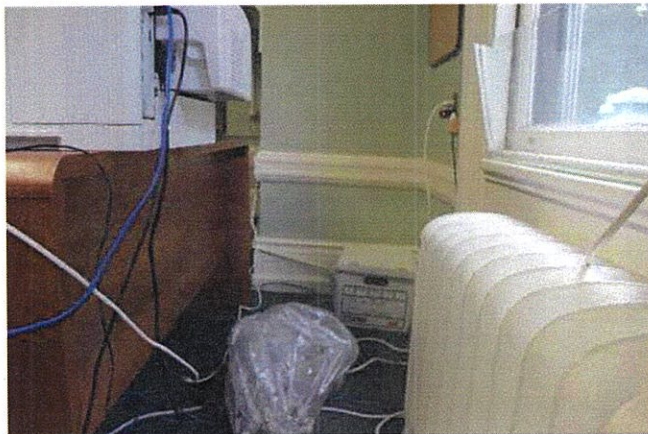
- I3. The second-floor framing at the displaced cantilevered portion mentioned in note E6 above was viewed at a probe through the second-floor finish. No deterioration or damage was noted but the support for the cantilevered portion was not evident.

I3. Sloping Floor Condition at Second Floor Cantilever

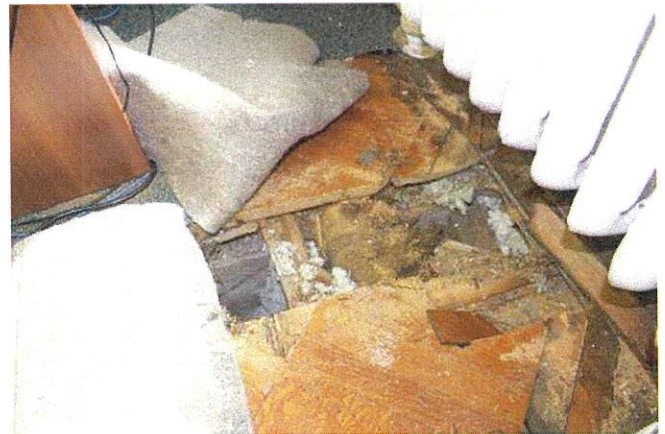
I3. Probe at Second Floor Cantilever

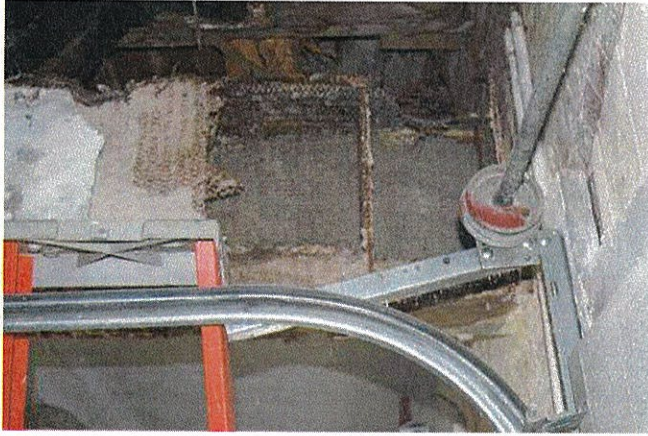
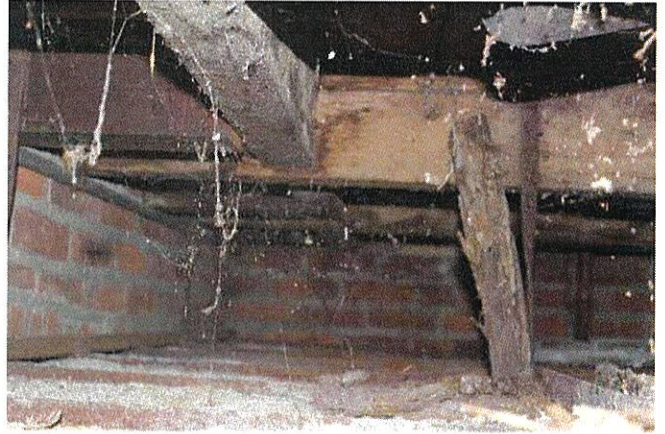
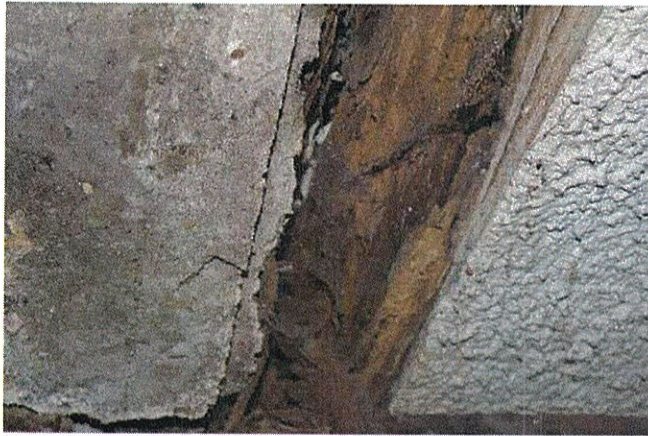
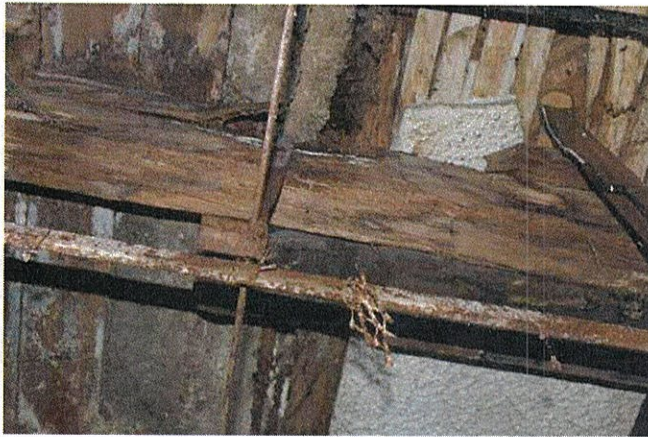
I4. Typical Conditions Below Second Floor Open Air Porch

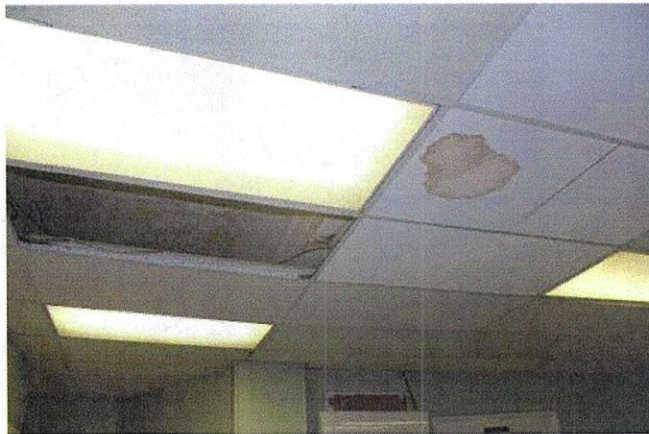
- I5. An active roof leak is evidenced by stained ceiling tiles above a second-floor office. The roof leak is presumed to be associated with a skylight above this location.

I5. Active Leak Above Second Floor Office

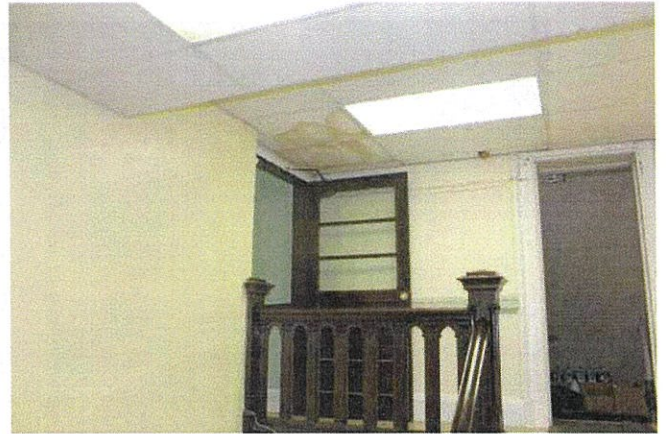
- I6. It was reported that portions of the ceiling and wall finishes have been previously replaced due to damage by moisture intrusion.

I6. Evidence of Roof Leak

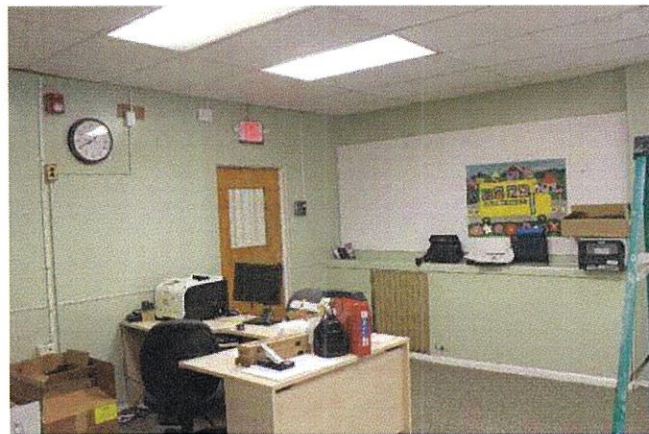
I5. Active Leak Above Second Floor Office

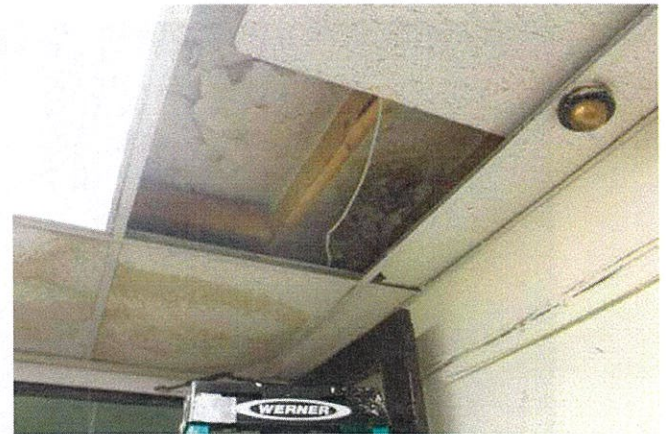
I6. Evidence of Roof Leak

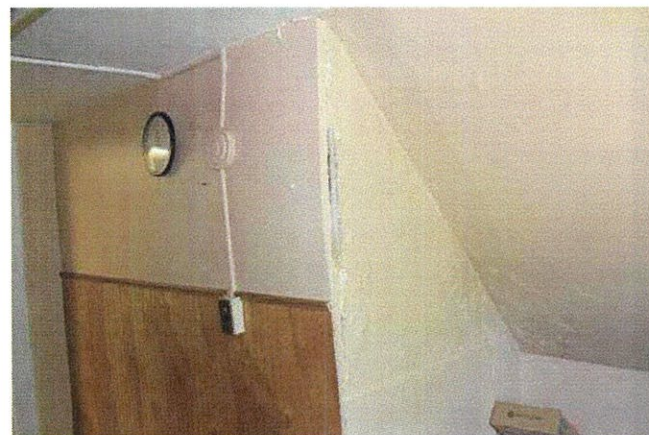
Evidence of Roof Leak

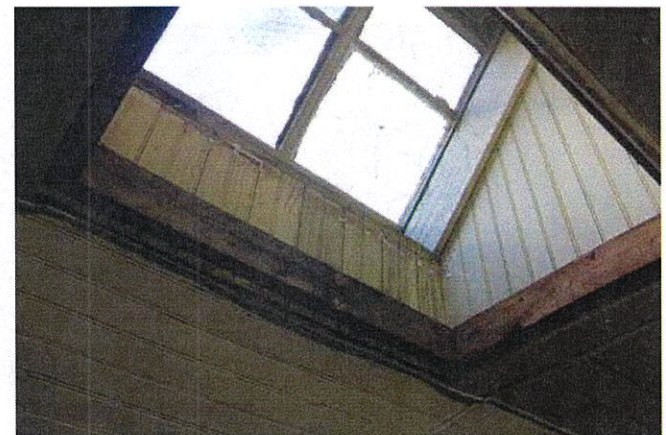
Evidence of Roof Leak

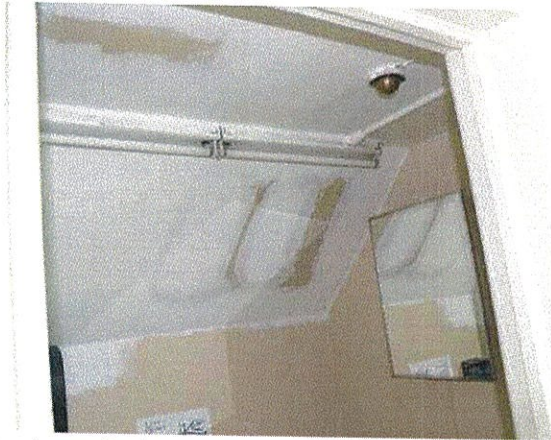
I6. Previously repaired ceiling at roof leak

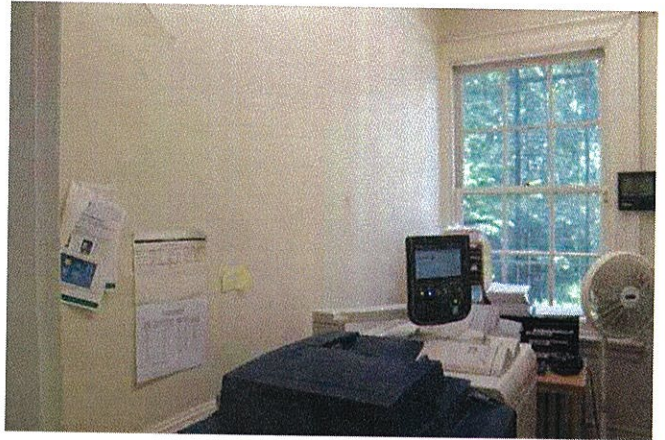
Damaged wall finish

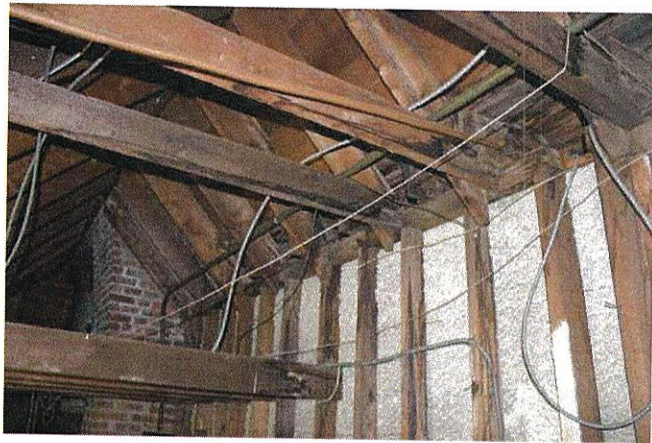
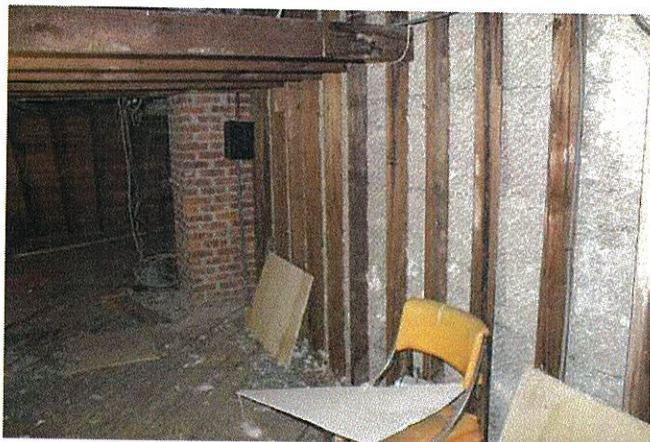
Evidence of roof leak in attic

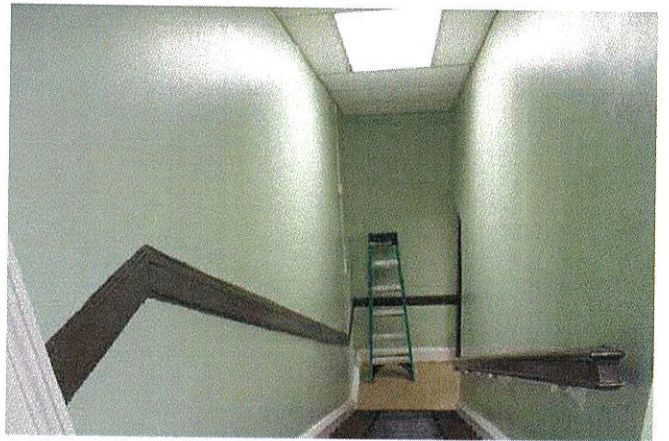
I6. Previously repaired wall at roof leak
